# Design Review Board

City of Greenville

Design Review Board – Neighborhood Panel

Application by LUKE SIMS for a CERTIFICATE OF APPROPRIATENESS for a new residence at 211 West Earle Street (TM# 0008000400600)

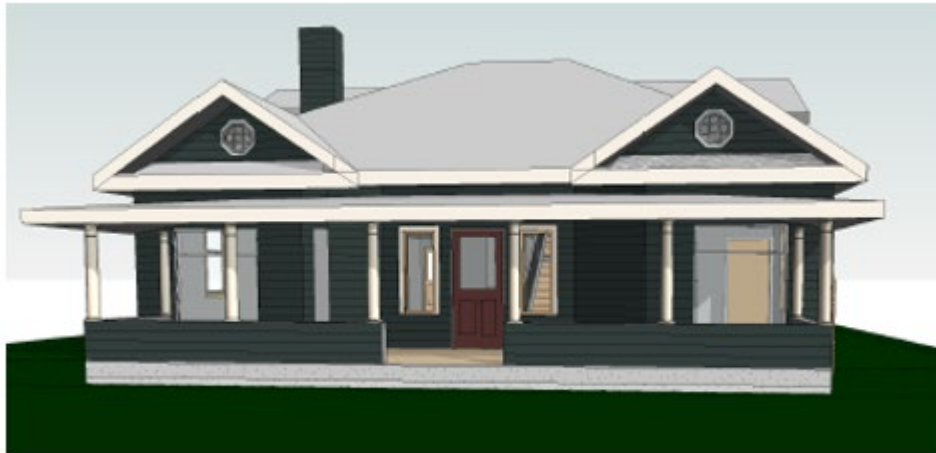
*Rendering from approved CA 21-159*

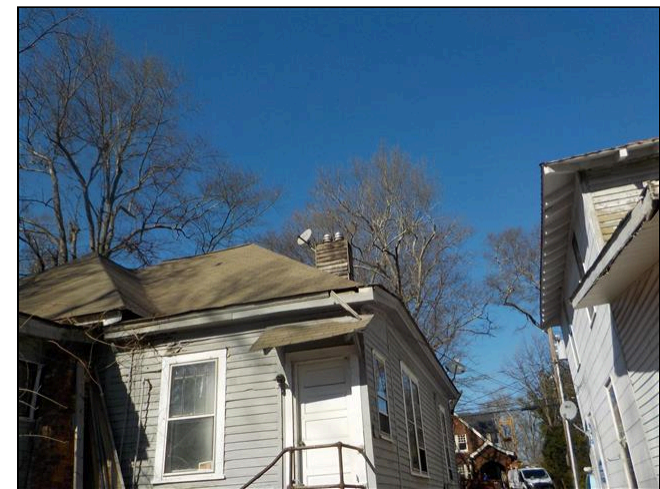
1.0 Item 1(Picture)

1.0 The roof covering is old, and the life of covering has expired. The covering does need to be replaced.

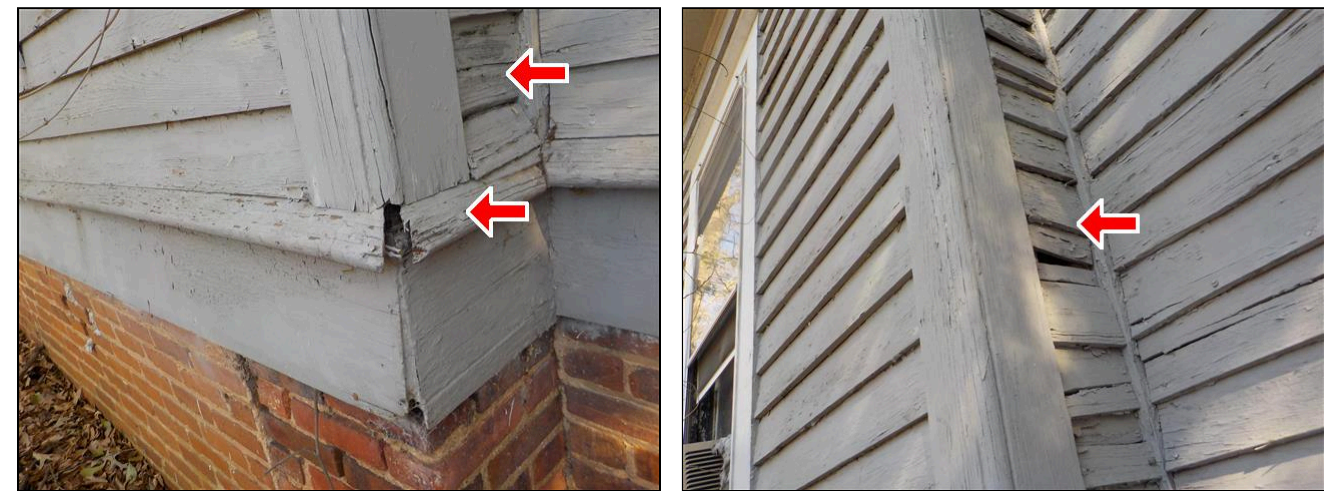
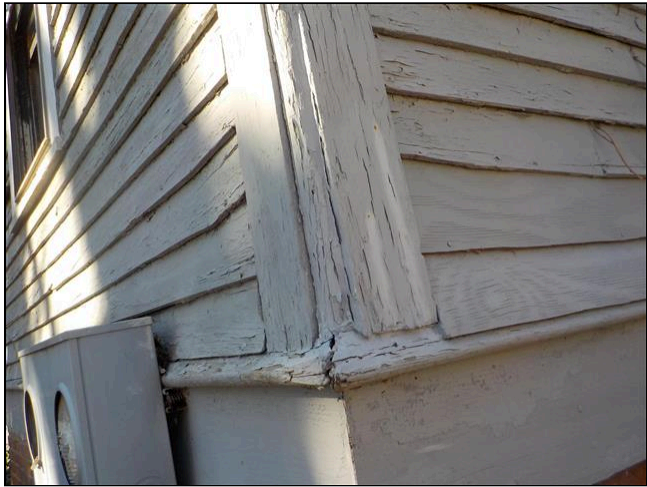
2.0 Item 1(Picture)

2.0 There are a good many areas the original siding is damaged . It may all need to be removed to repair the structure.

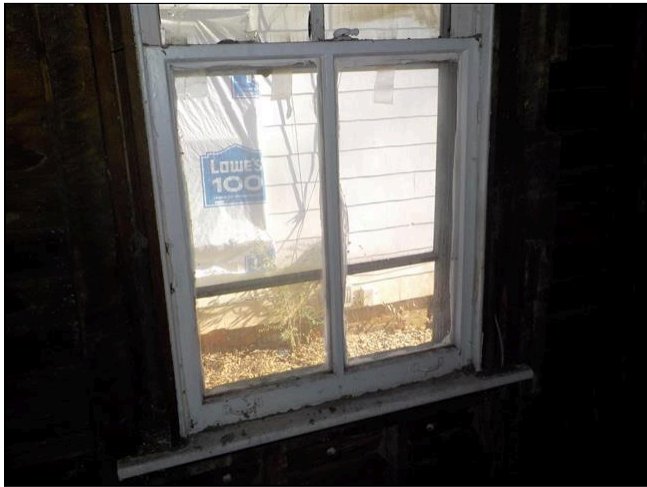
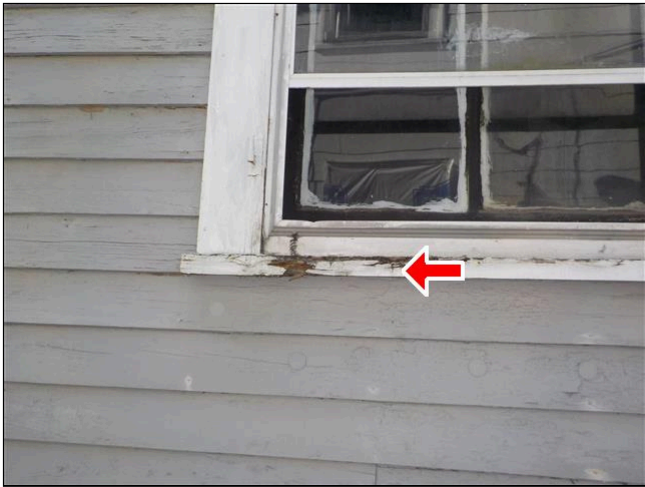
2.2 Item 1(Picture)

2.2 All windows are old and damaged and need to be replaced

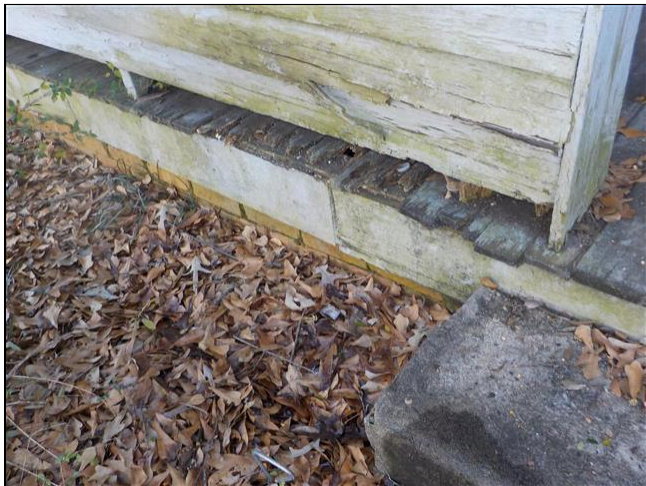
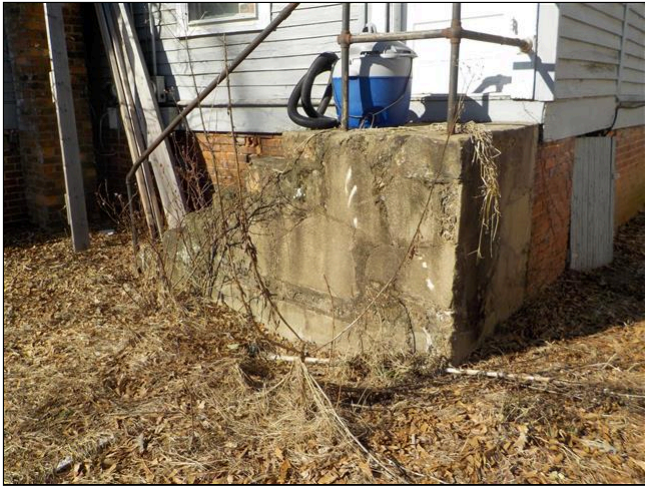
2.3 Item 1(Picture)

2.3 (1) Most of the front porch structure is covered. With the water that is dripping out of the roof and the way the porch is sagging there is a good possibility the front porch will need to be replaced. There has also been incorrect use of materials

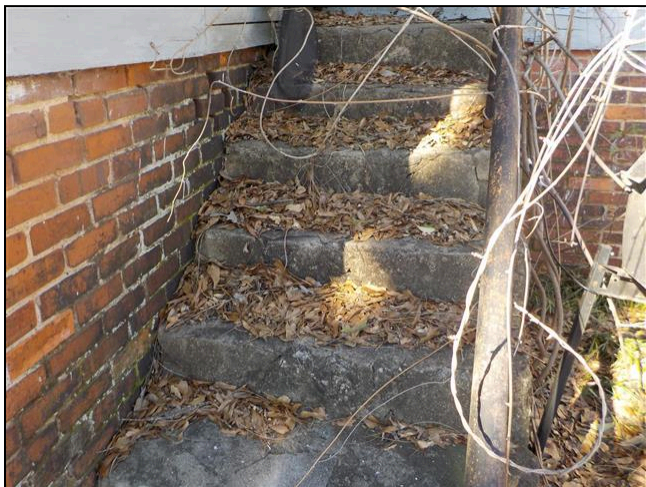
2.3 Item 7(Picture)

**2.3** (2) Both sets of stairs at rear are deteriorated and need to be replaced.

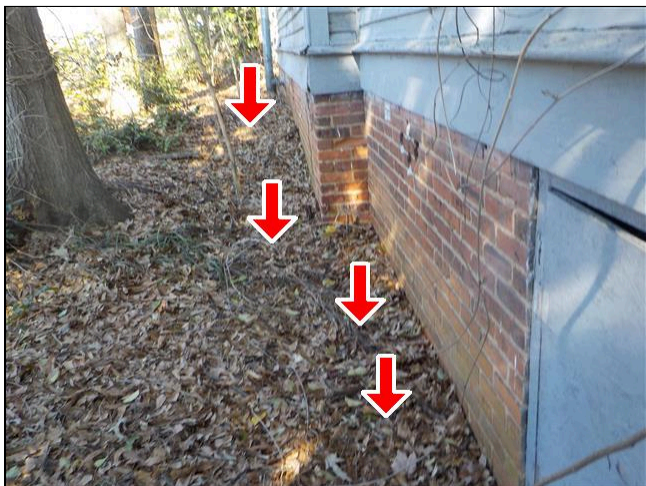
2.4 Item 1(Picture)

**2.4** The ground on the right side of house will need filling to help keep water out of the crawl.

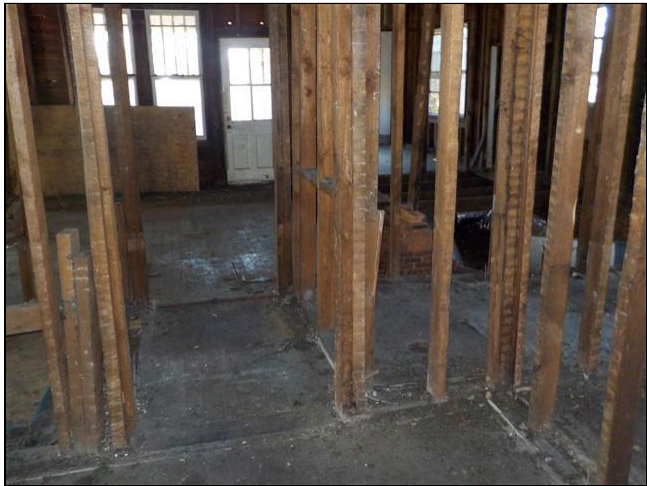
3.1 Item 1(Picture)

3.1 There is no interior walls , doors or trim that is in the house. Just wall studs .

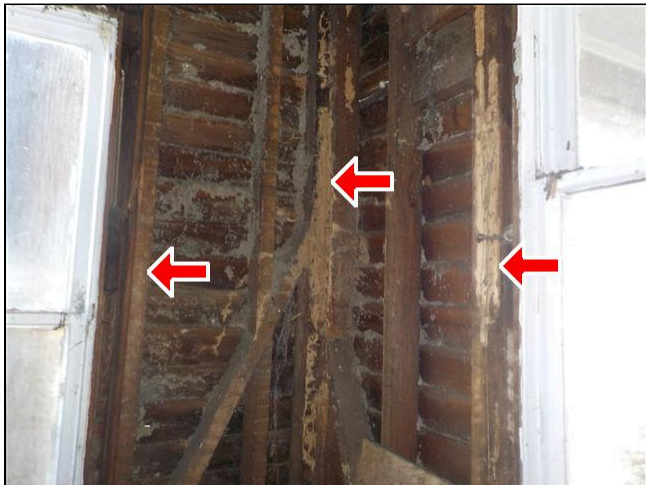
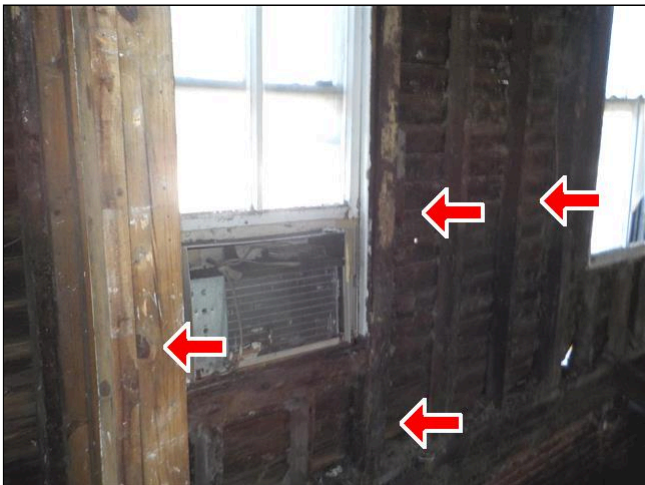
4.1 Item 1(Picture)

4.1 The wall structure in the front right and center rooms is damaged from water and termites. It will need to be completely replaced . Some of the front wall in the room will also be need to be replaced. There are some small areas of the structure in various places that will also needed repair

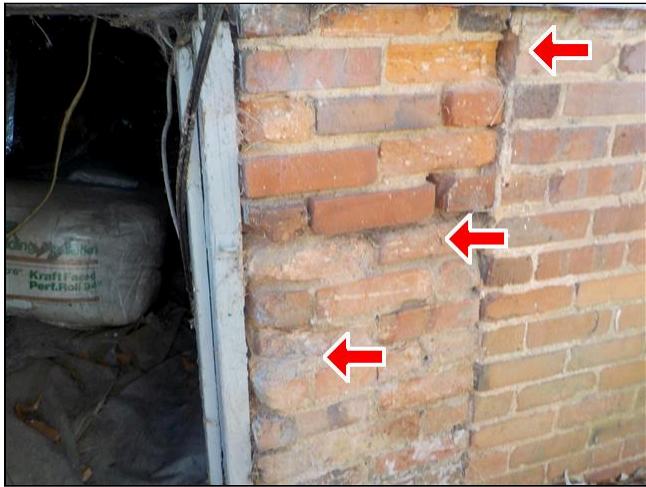
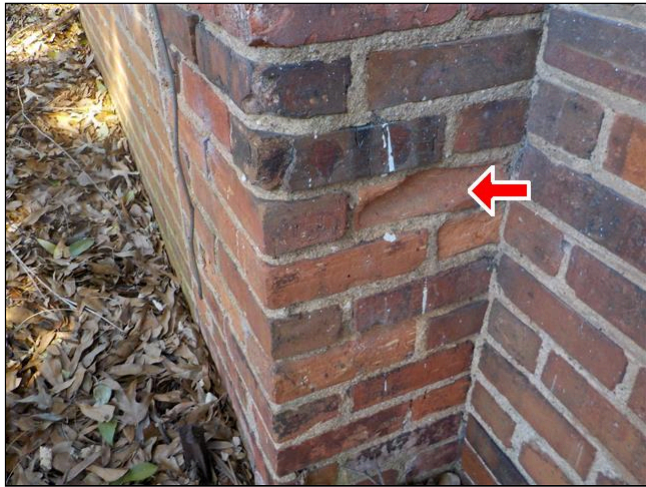
4.2 Item 1(Picture)

4.2 (1) The house was originally built on piers with no foundation wall. I believe the wall supports no load . The exterior piers are deteriorating and may need to be replaced . With this repair the wall may also need to be replaced. The internal piers appear in good shape but should be examined to make sure they are stable.

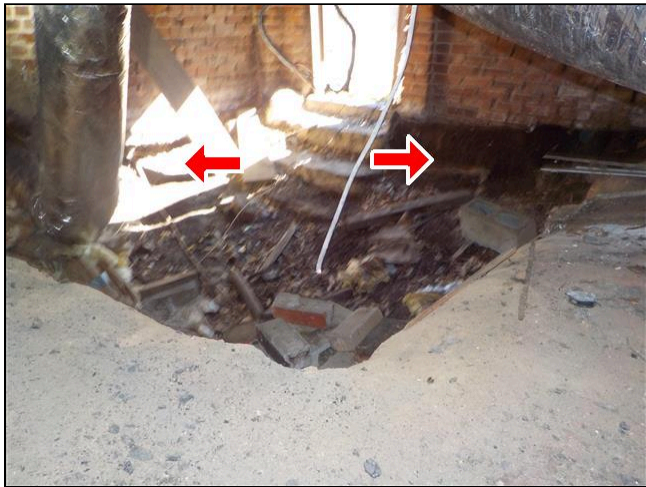
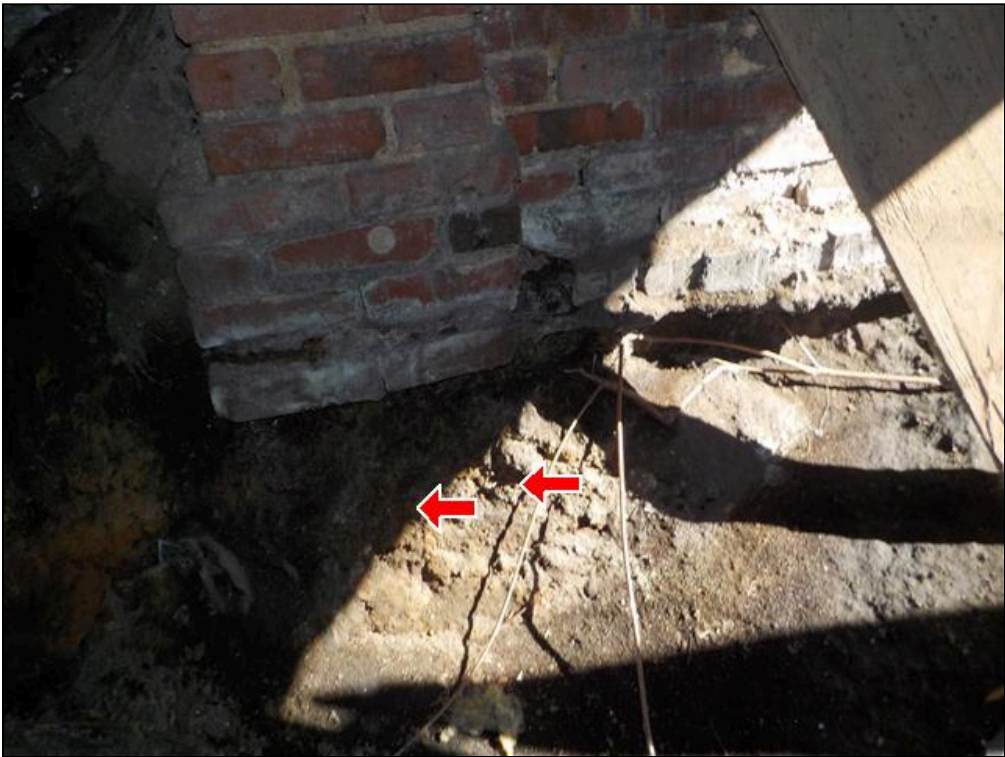
4.2 Item 3(Picture)

4.2 (2) The pit in the crawl at rear needs to be filled in . It has exposed the foundation wall below the footings of the piers and this makes them unstable

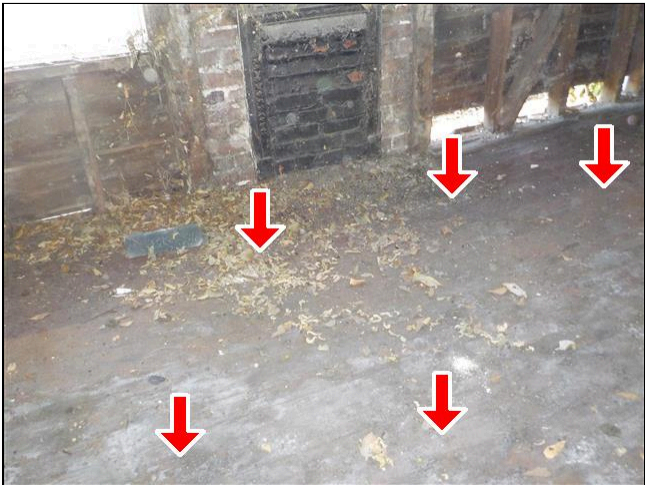
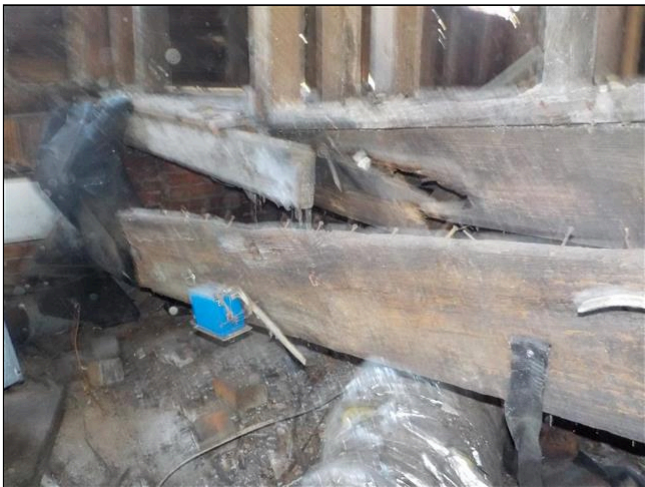
4.3 Item 1(Picture)

4.3 The floor structure in the front and center rooms on the right will need to be completely replaced. There are other small areas that will also need repair.

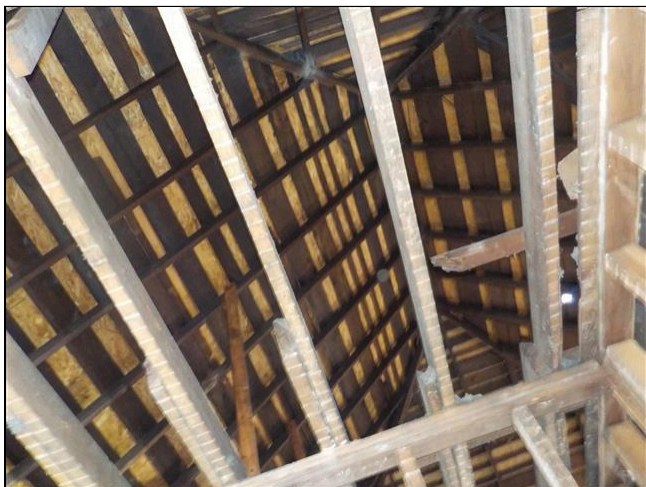
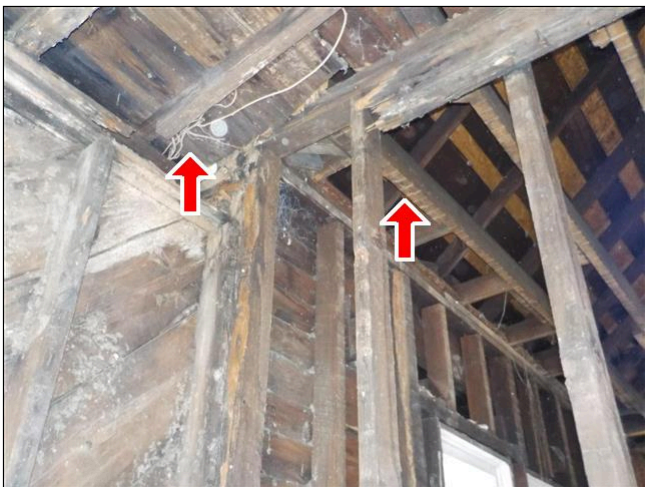
4.5 Item 1(Picture)

4.5 For the most part the roof structure is in good shape. There are some small areas that have damage but should be able to be repaired. The last time shingles were installed OSB was used to cover the roof .

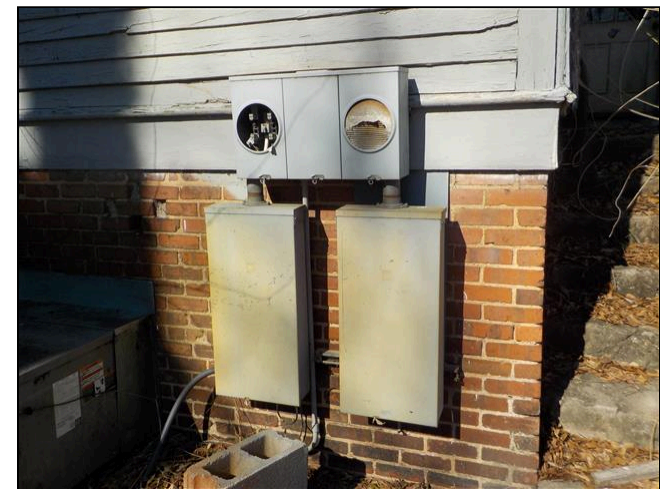
6.0 Item 1(Picture)

6.0 The is no functional electrical system.

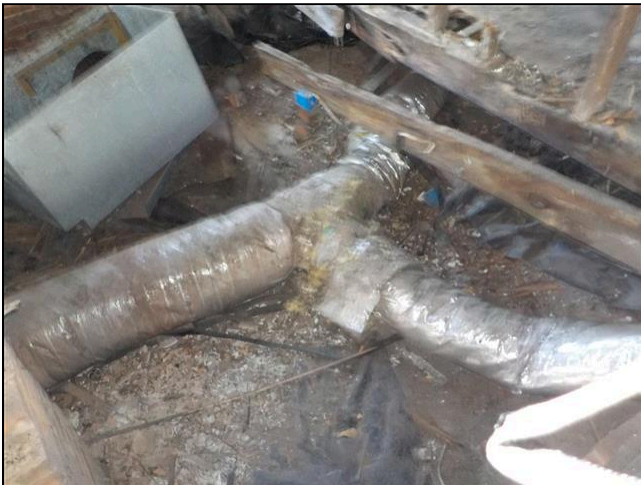
7.0 Item 1(Picture)

7.0 There is no functional HVAC or ductwork.

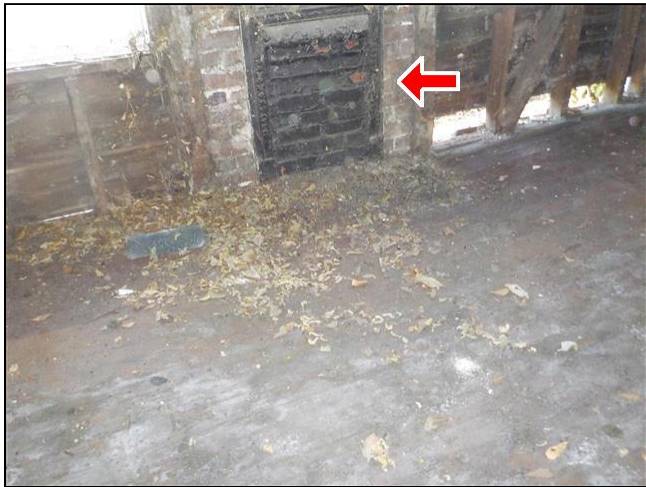
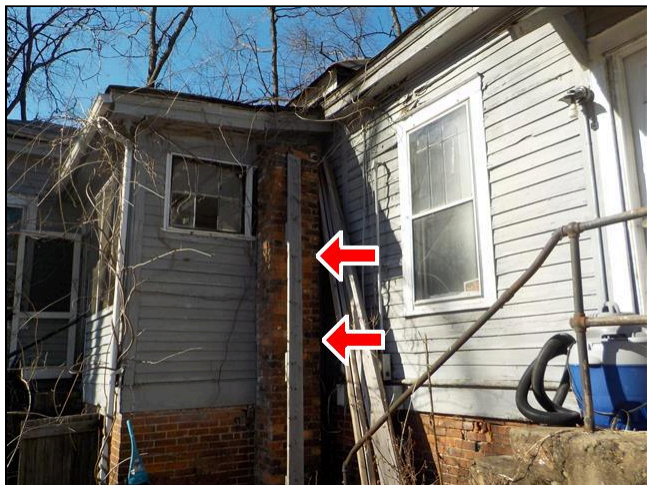
7.5 Item 1(Picture)

7.5 All chimneys are deteriorated and will need to be removed. The top has already been removed on one.

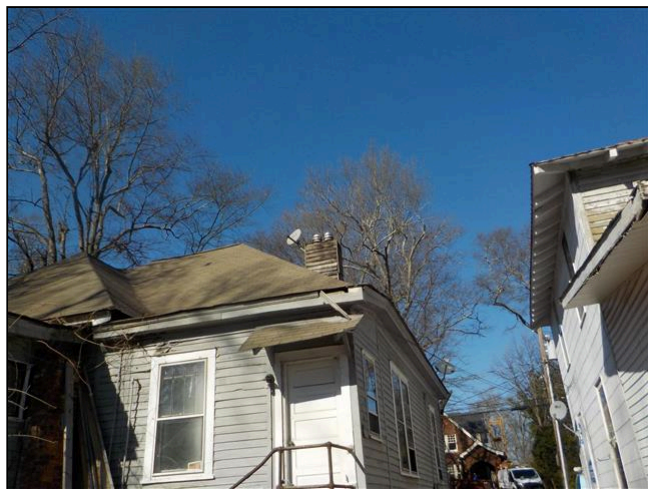
1.0 Item 1(Picture)

The roof covering is old, and the life of covering has expired. The covering does need to be replaced.

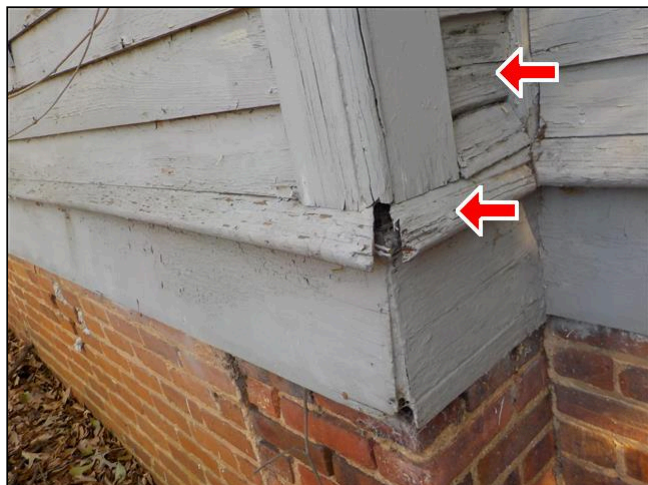
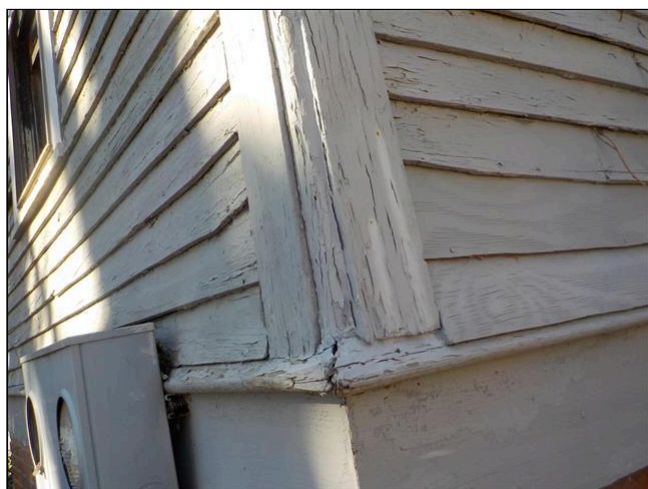
2.0 Item 1(Picture)

There are a good many areas the original siding is damaged . It may all need to be removed to repair the structure.

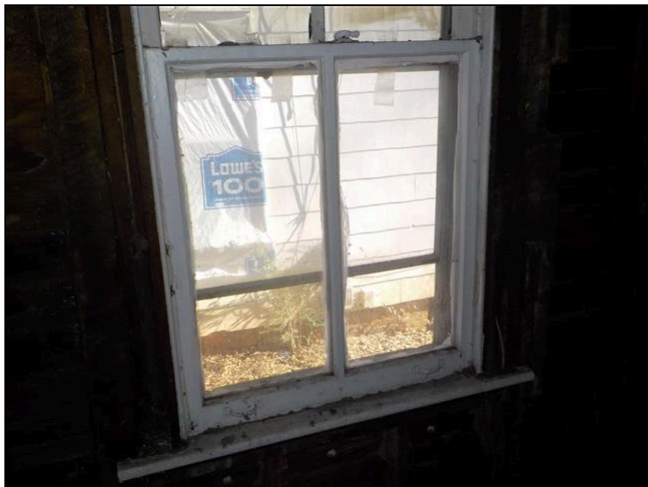
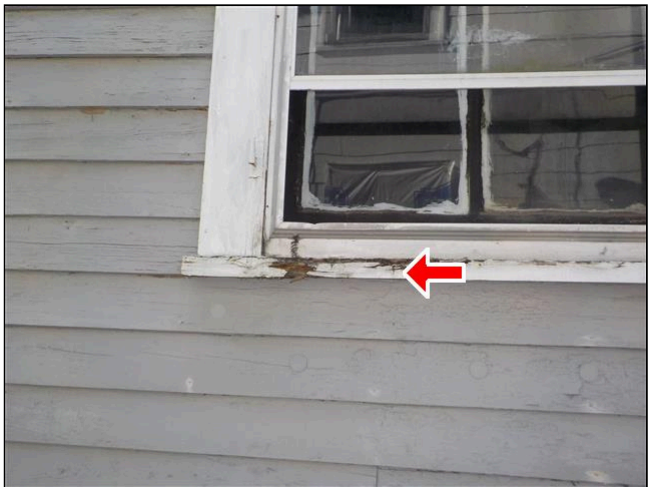
2.2 Item 1(Picture)

All windows are old and damaged and need to be replaced

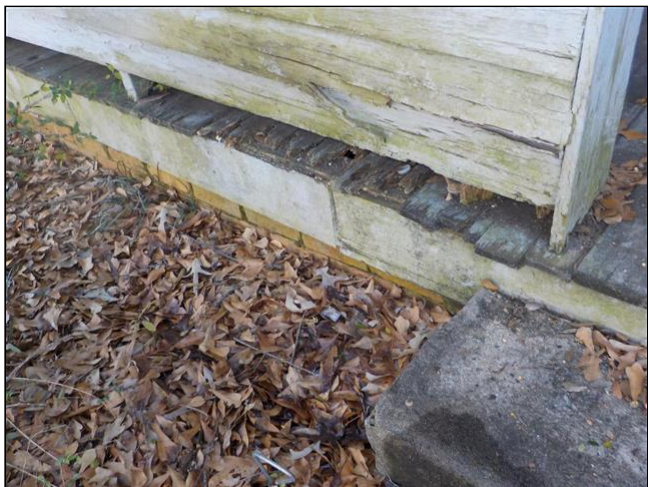
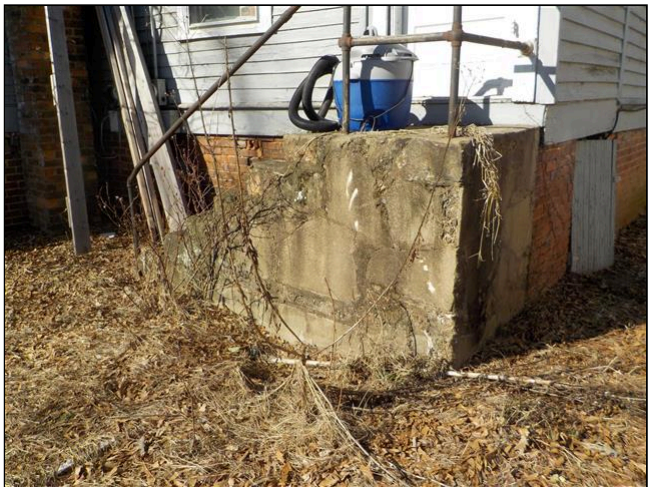
2.3 Item 1(Picture)

(1) Most of the front porch structure is covered. With the water that is dripping out of the roof and the way the porch is sagging there is a good possibility the front porch will need to be replaced. There has also been incorrect use of materials

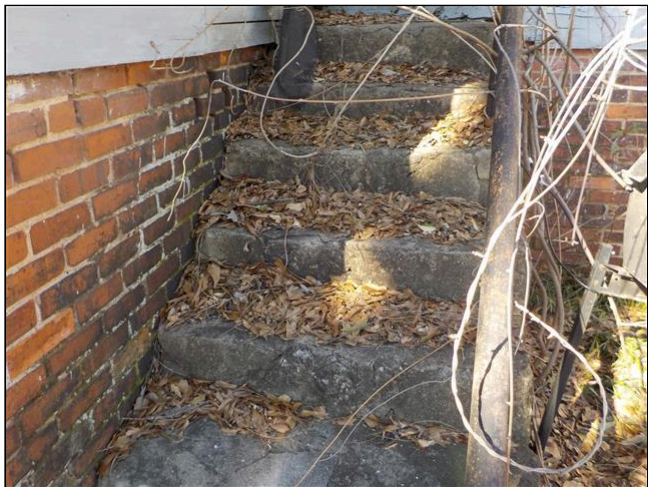
2.3 Item 7(Picture)

(2) Both sets of stairs at rear are deteriorated and need to be replaced.

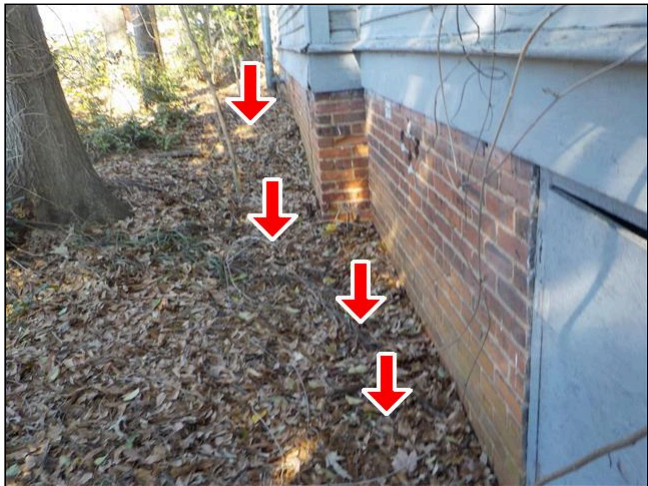
2.4 Item 1(Picture)

The ground on the right side of house will need filling to help keep water out of the crawl.

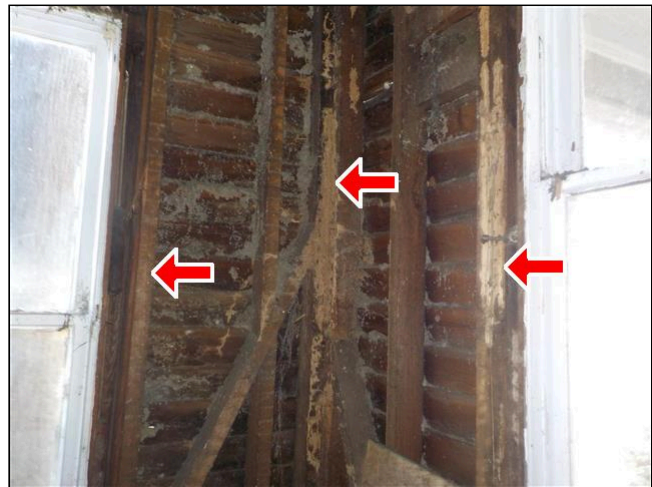
4.1 Item 1(Picture)

The wall structure in the front right and center rooms is damaged from water and termites. It will need to be completely replaced . Some of the front wall in the room will also be need to be replaced. There are some small areas of the structure in various places that will also needed repair

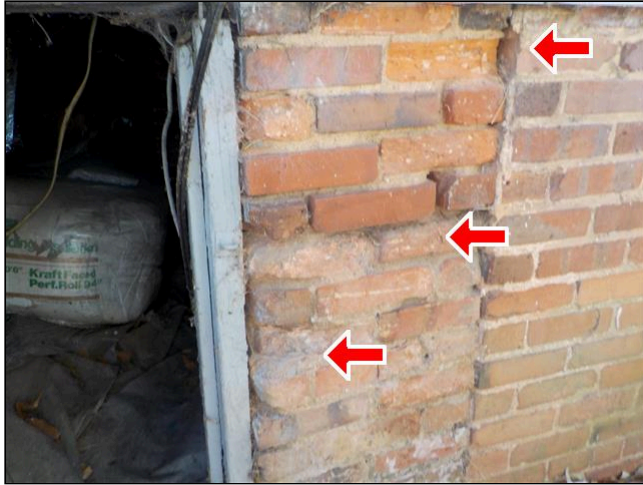
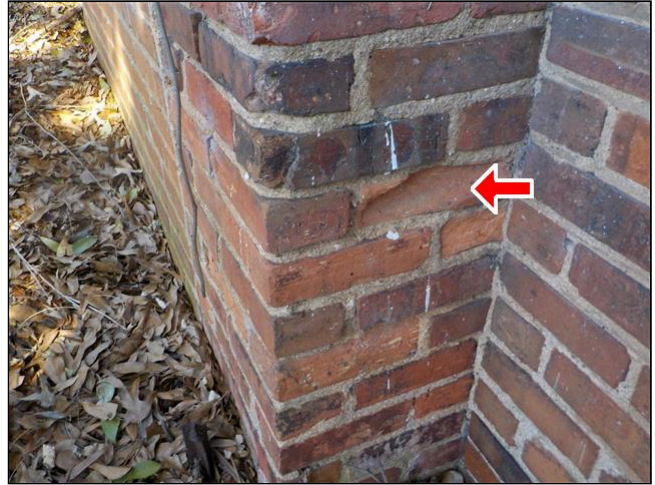
4.2 Item 1(Picture)

(1) The house was originally built on piers with no foundation wall. I believe the wall supports no load . The exterior piers are deteriorating and may need to be replaced . With this repair the wall may also need to be replaced. The internal piers appear in good shape but should be examined to make sure they are stable.

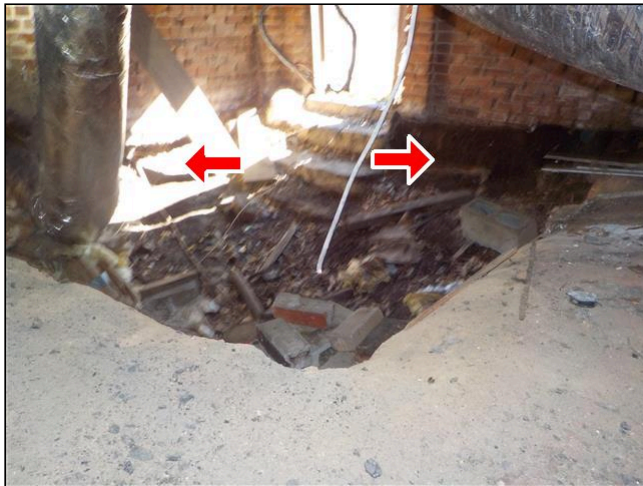
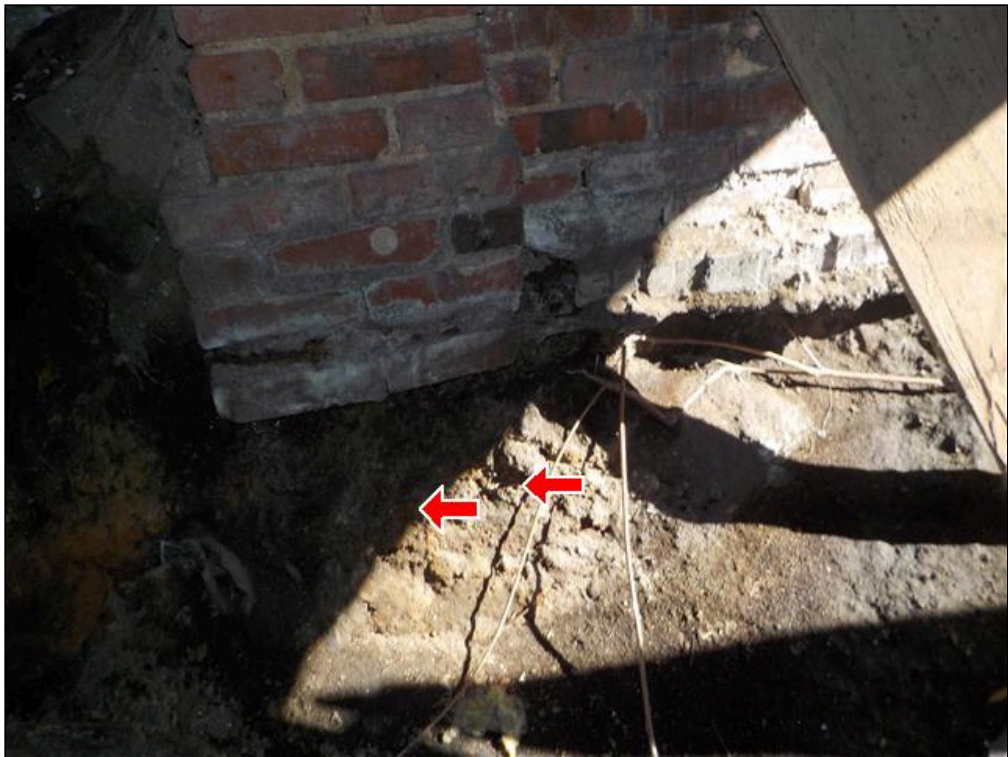
4.2 Item 3(Picture)

(2) The pit in the crawl at rear needs to be filled in . It has exposed the foundation wall below the footings of the piers and this makes them unstable

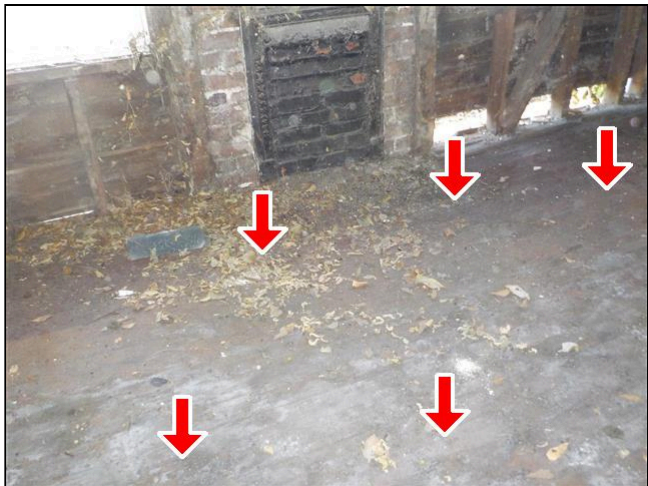
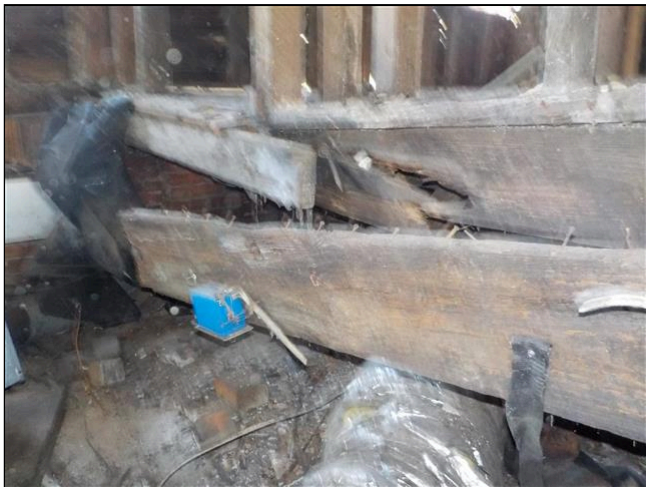
4.3 Item 1(Picture)

The floor structure in the front and center rooms on the right will need to be completely replaced. There are other small areas that will also need repair.

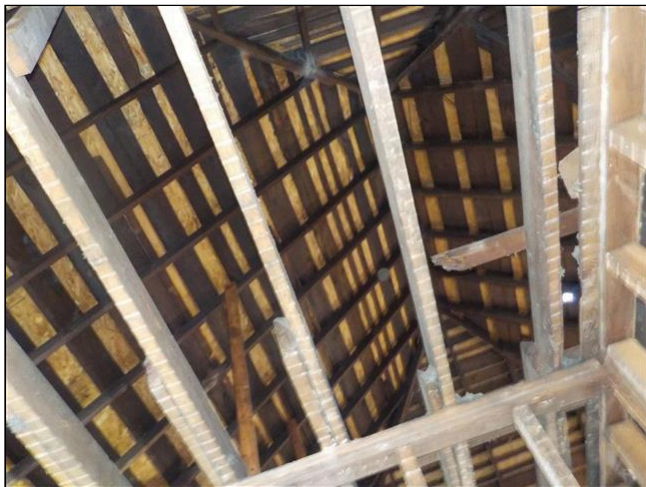
4.5 Item 1(Picture)

For the most part the roof structure is in good shape. There are some small areas that have damage but should be able to be repaired. The last time shingles were installed OSB was used to cover the roof .

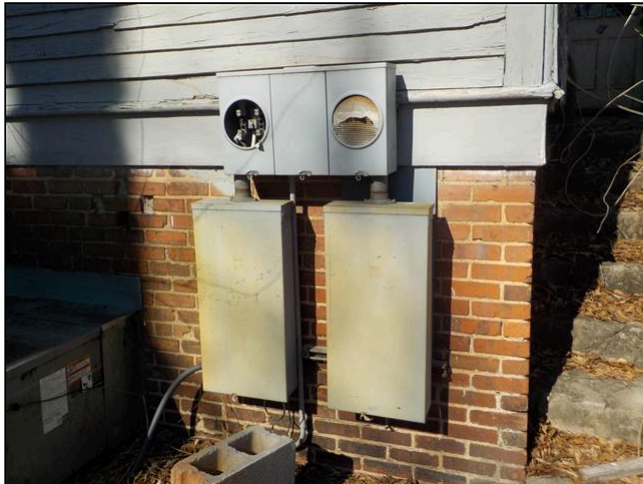
6.0 Item 1(Picture)

The is no functional electrical system.

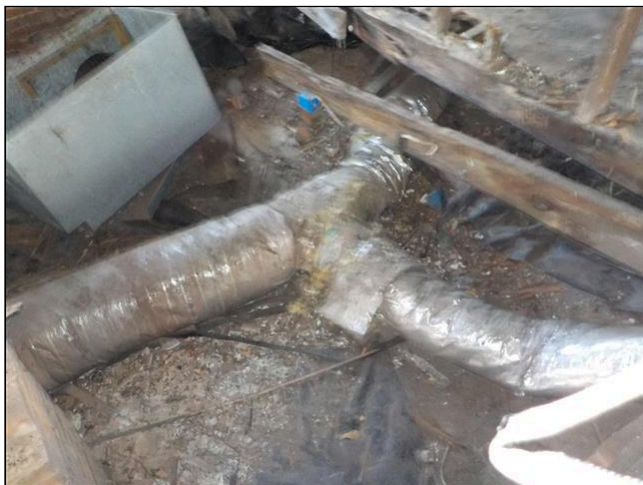
7.0 Item 1(Picture)

There is no functional HVAC or ductwork.

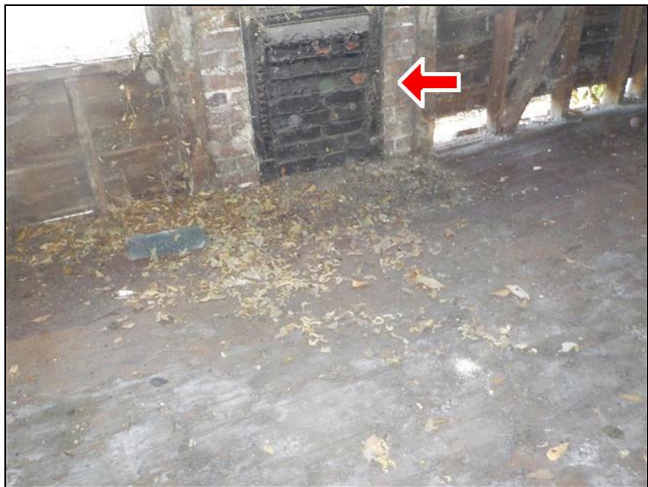
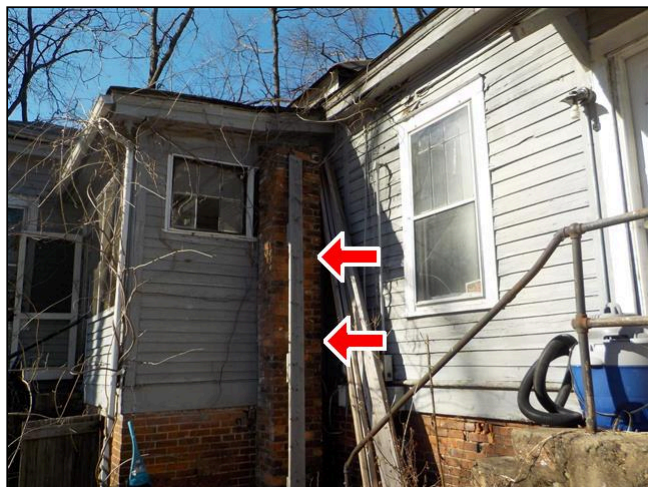
7.5 Item 1(Picture)

All chimneys are deteriorated and will need to be removed. The top has already been removed on one.

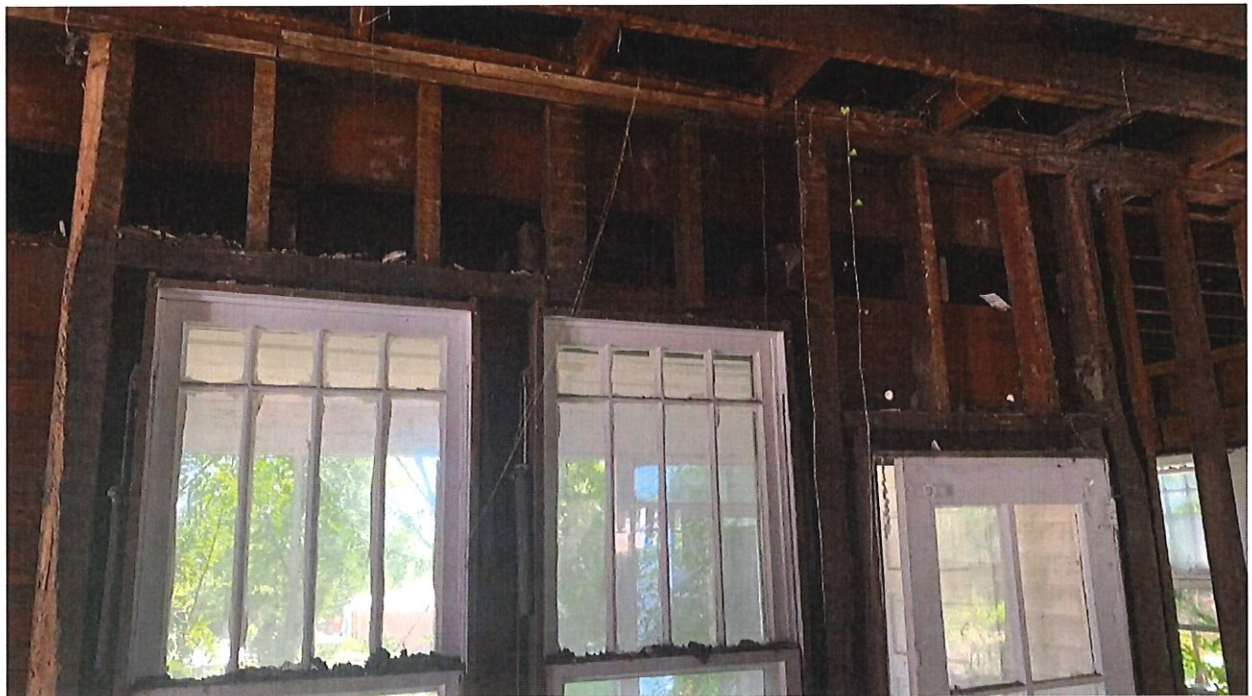
PHOTO #2

2. Our observations regarding concerns with the present structure are as follows:
  - a. The headers over the doors and windows are typically one or two 2 x 4s turned in the weak direction (see photo #2). Deflection of the members was observed at some of the headers.

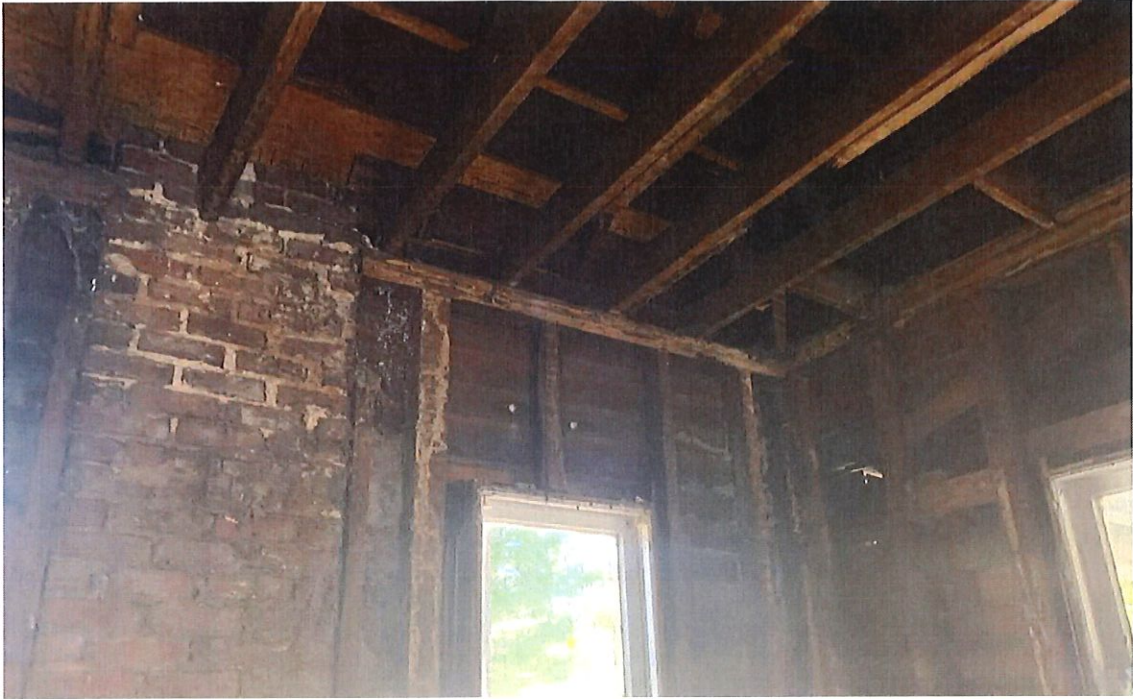
**PHOTO #3**

- b. Termite damage was observed in the wall framing at the front right corner, front left corner, and rear wall of the building (see photos #3 and #4). We also observed that there is no sheathing or vapor barrier on the exterior face of the walls.

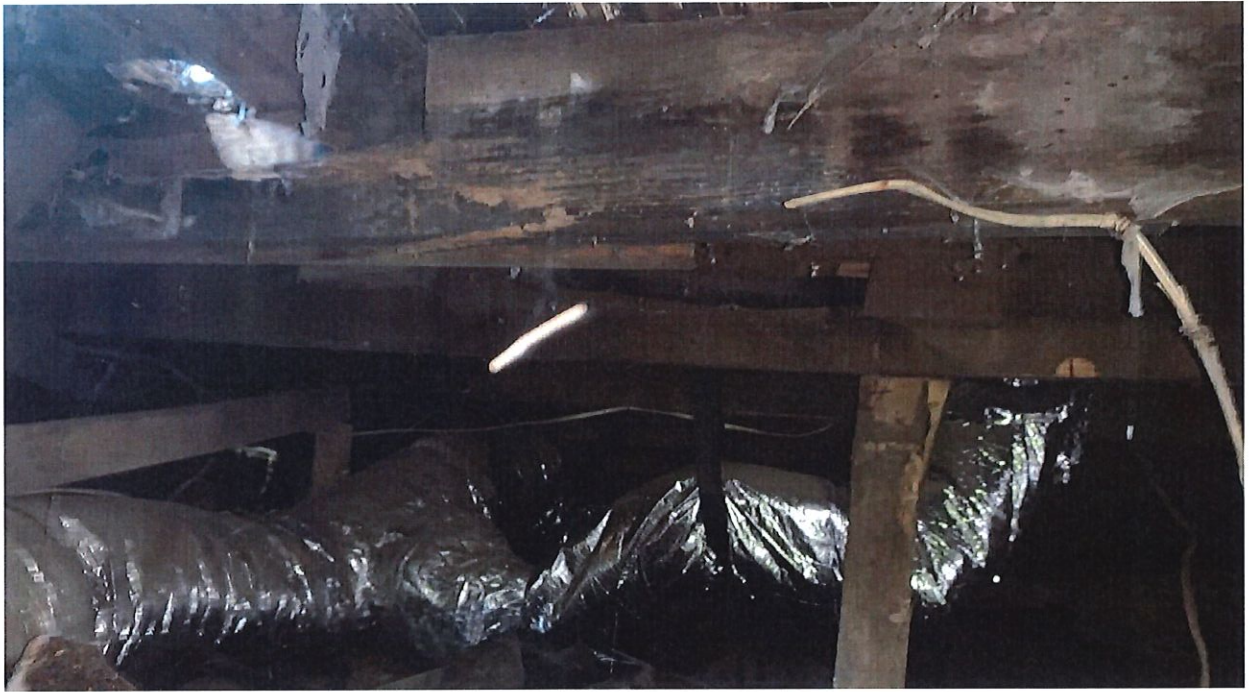
PHOTO #5

- c. Water damage was observed at the floor framing in the Kitchen and Bathroom areas and along the band board that supports the exterior wall (see photo #5 and #6). Some of the floor framing in the Kitchen area has already been removed.

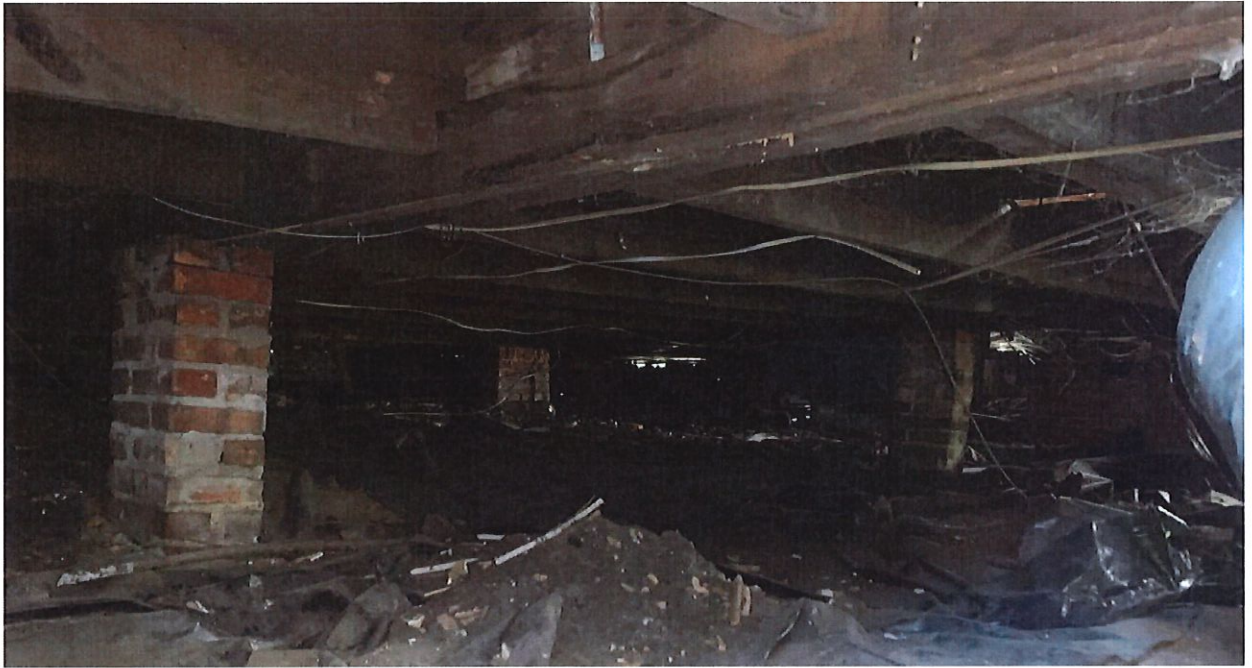
PHOTO #7

- d. The floor joists are 2 x 8's at 24" o.c. spanning about 13'-6". The beams and piers are not adequate to support the main floor framing, proposed second floor framing, and the new roof (see photo #7).
- d. The existing ceiling joists are 2 x 6's at 16" o.c. (see photo #8). They are not adequate to be floor joists for the proposed second floor.
- e. From the exterior appearance of the house, it is obvious that this house has not been properly maintained in several years (see photo #9).
