# Design Review Board

City of Greenville

Design Review Board – Neighborhood Panel

Application by LUKE SIMS for a CERTIFICATE OF APPROPRIATENESS for a new residence at 211 West Earle Street (TM# 0008000400600)

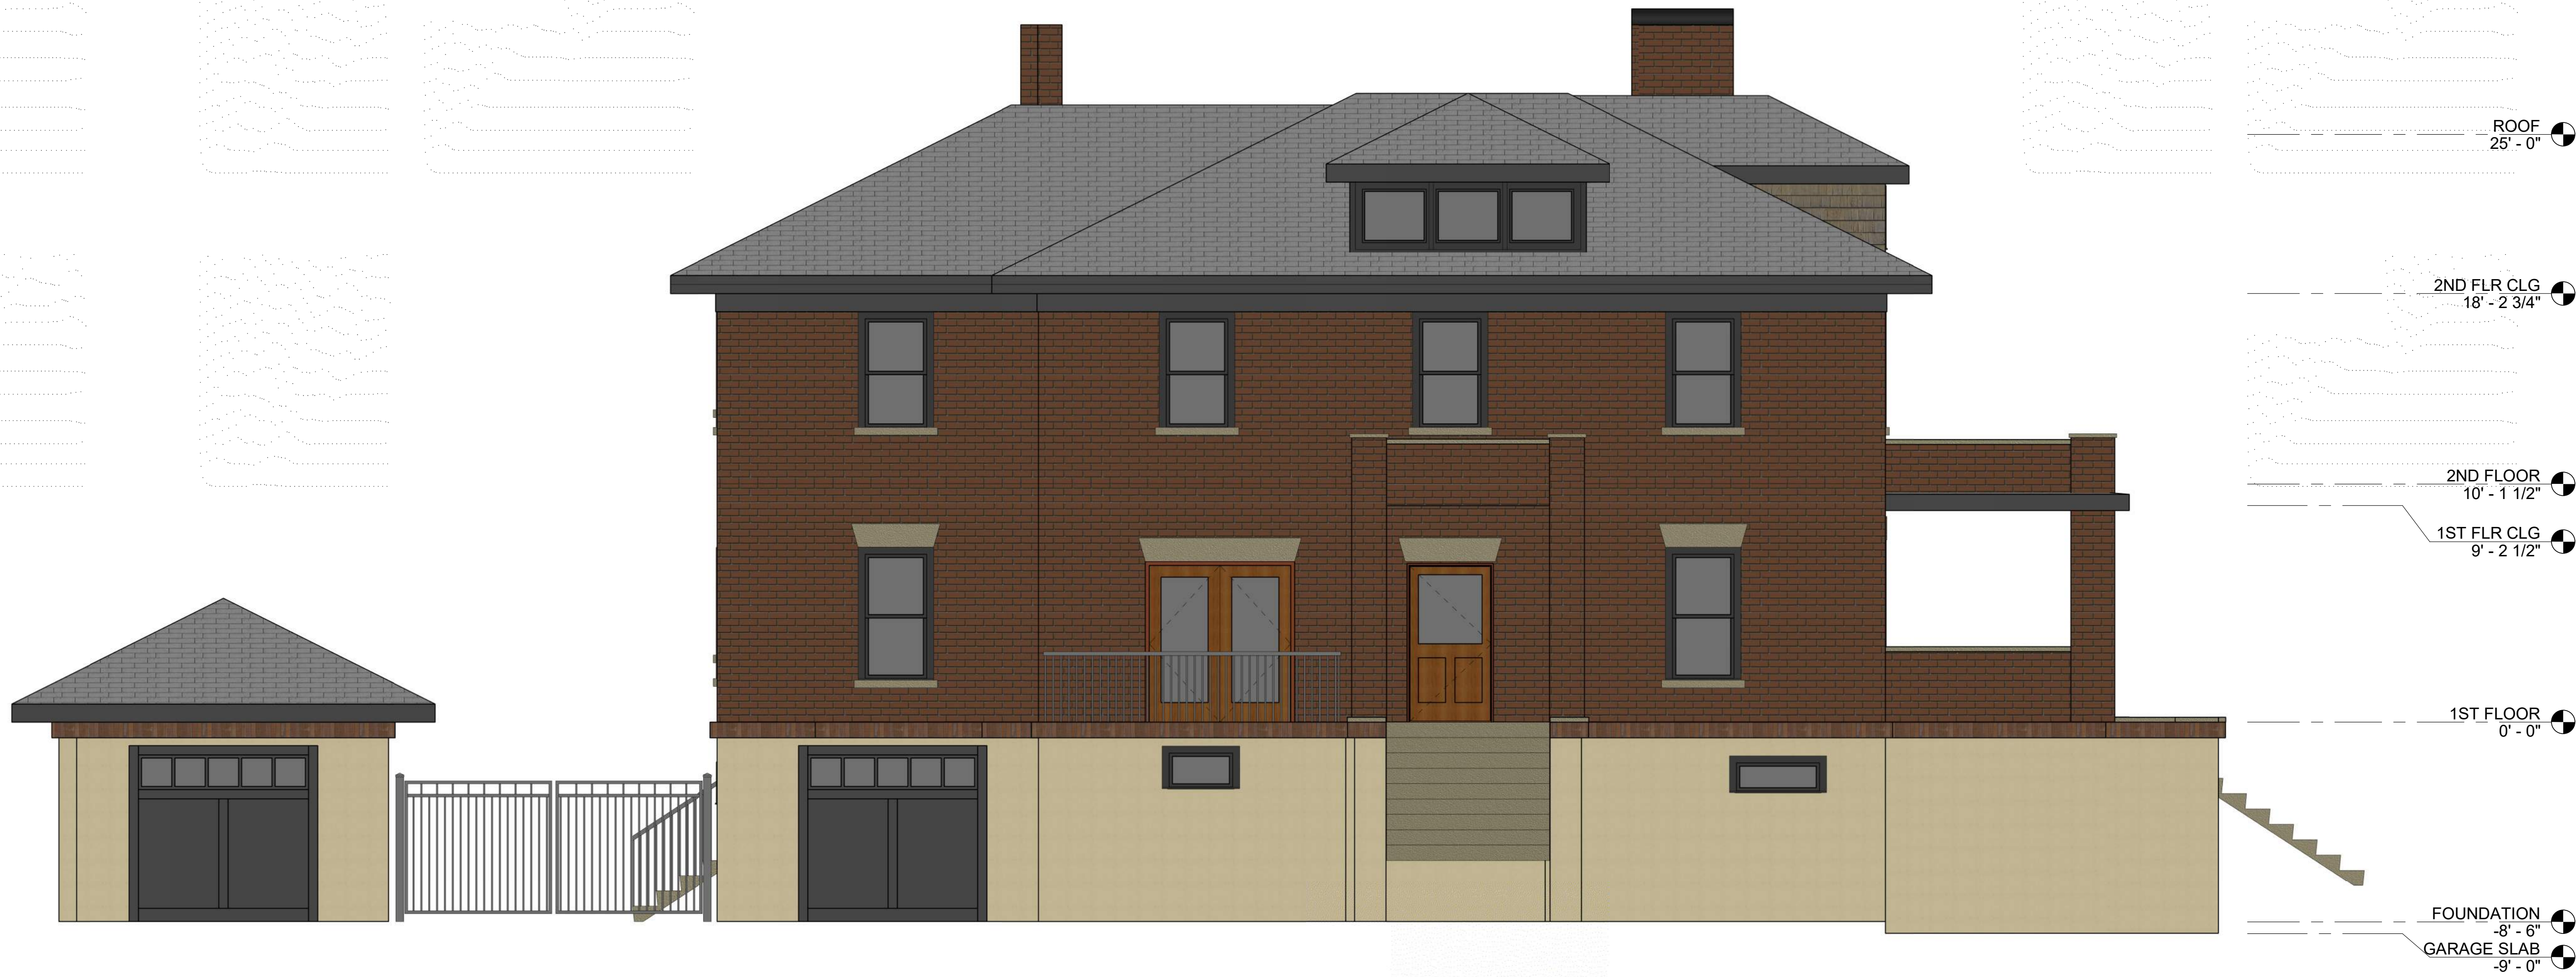
2 Elevation 2 - a  
1/4" = 1'-0"

THE LINE SHOWN ABOVE  
INDICATES THE LOCATION OF  
THE FOUNDATION SLAB
