MEETING OF DESIGN REVIEW BOARD

THURSDAY, AUGUST 21, 2025 - 4:00 PM

**Planning Staff Report to  
Design Review Board  
August 15, 2025**  
*for the August 21, 2025 Public Meeting*

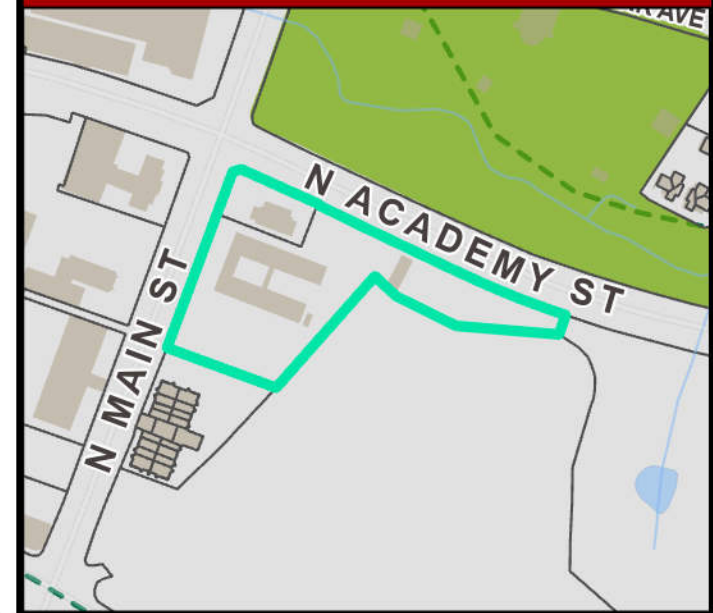
INCREASE BUILDING 1  
HEIGHT BY (2) STORIES

EXTEND BUILDING FOR  
DIRECT ENTRY INTO  
GARAGE

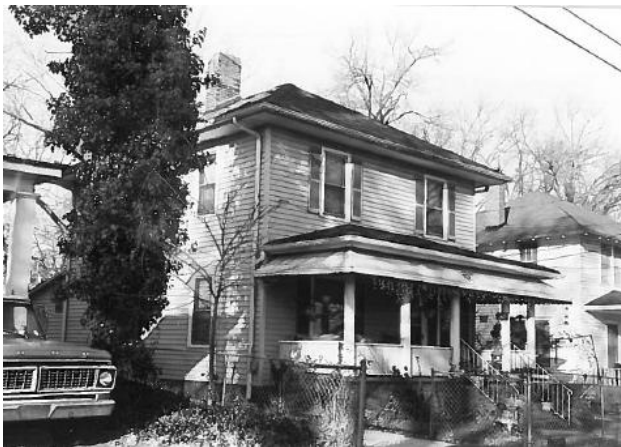
*Photo from Greenville's Historic Resource Survey - 2002*

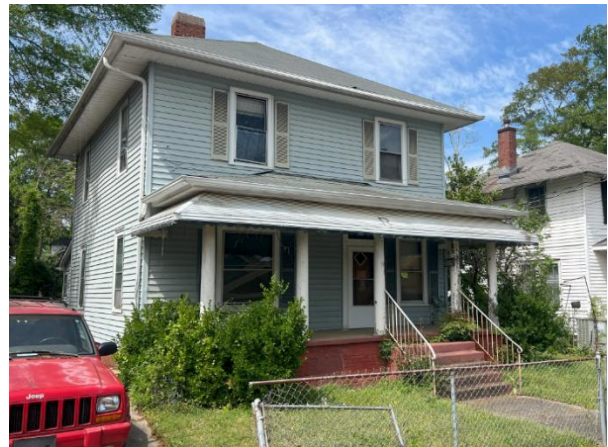
*Current Photo*

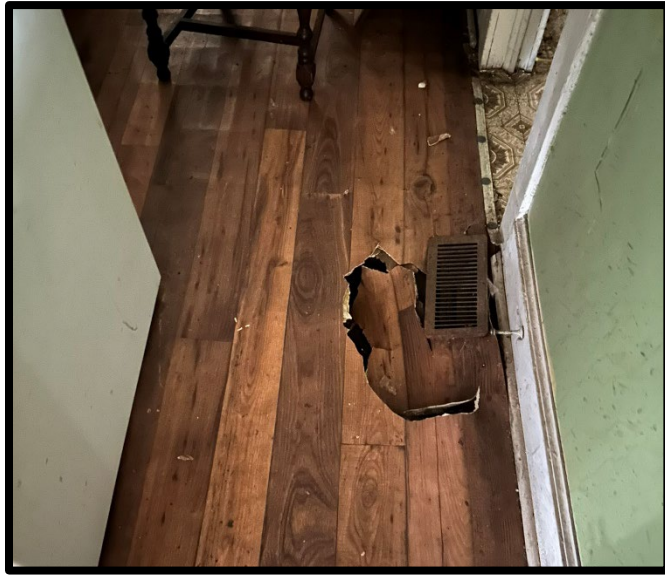
PHOTO 1.

1. Unlevel and unfinished floors on the first level, with local height variations in some places as high as 0.5”.
2. Holes in floors in the middle of typical walkpaths, all the way through to the crawlspace below (see Photo 1).
3. Disconnected HVAC and appliance ductwork and hosing (see Photo 2).
4. Water and moisture damage on vertical walls throughout the interior of the house (see Photo 3).
5. Broken and disconnected plumbing fixtures.
6. Drooping ceilings near exterior walls (see Photo 4).
7. Various openings, such as windows and doors, are not air or weather tight.
8. Water damage on ceiling of second level (see Photo 5).
9. Live vegetation growth from exterior at windows into the interior of structure (see Photo 6).
10. Rotten and improperly supported ceiling systems, likely the result of prolonged weather exposure (see Photo 7).

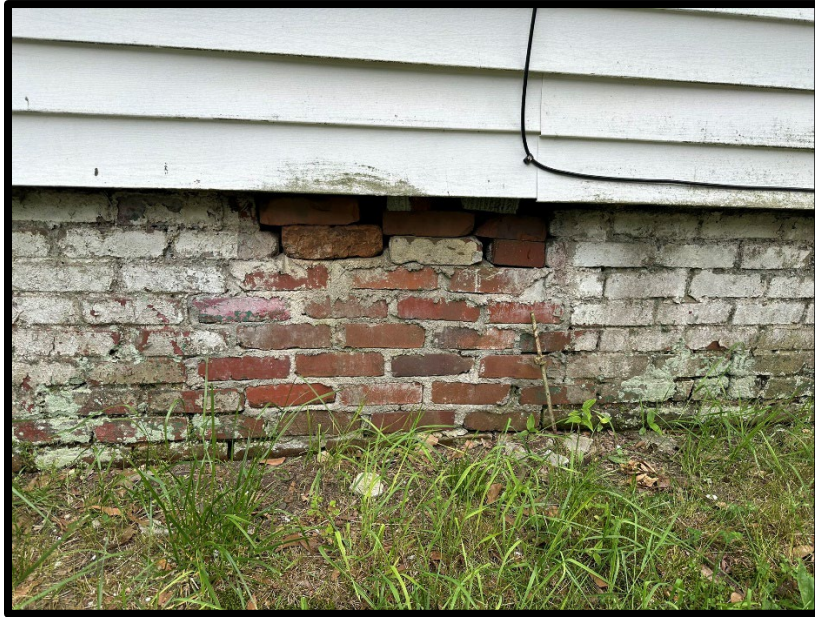
**PHOTO 1.**

1. Incomplete foundation curtain wall (see Photo 1).
2. Inadequate crawlspace access (see Photo 2).
3. Exterior rear patio at imminent risk of caving due to lack of compacted soil immediately below (see Photo 3).
4. Rotting and exposed framing at exterior openings (windows – See Photo 4).
5. Improperly supported ceiling system of front porch (see Photo 5).
6. Unlevel and unfinished floors on the first level, with local height variations in some places as high as 0.5” (see Photo 6).
7. Permanent openings in ceiling, exposed to unfinished and unconditioned space (see Photo 7).

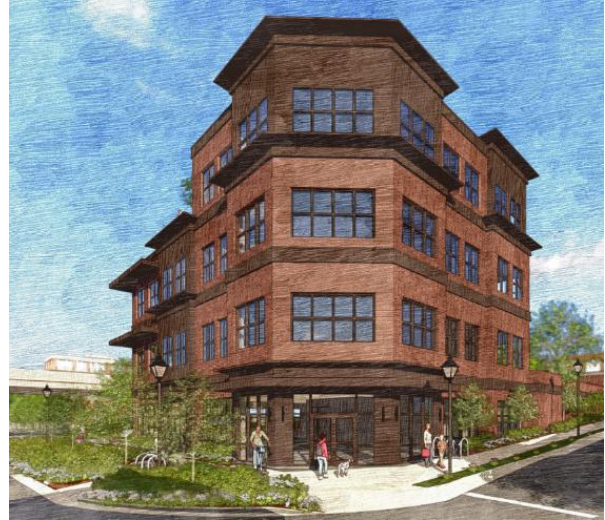
Per PRI 1.1, the building frontage is aligned along the sidewalk edge and oriented toward the public realm. The proposed on-site parking is located to the rear of the building, per PRI 1.4.

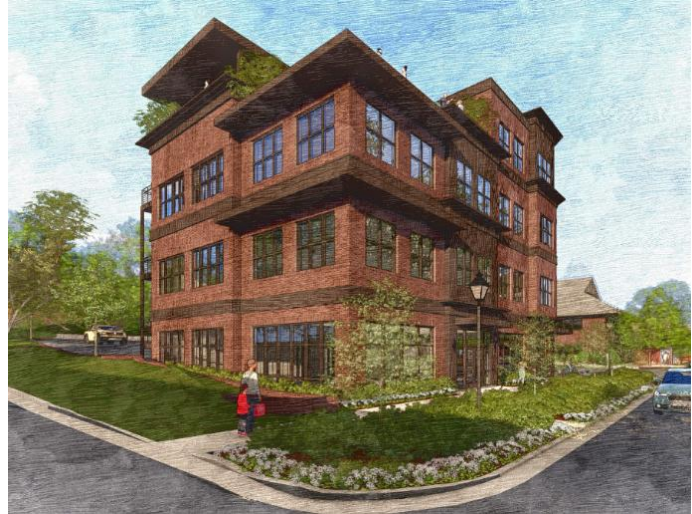
Per PRI 3.2, the entry that faces the public realm is designed to accommodate all levels of physical ability. Staff finds that the entry design is pronounced well and enhanced by expansive glass, lighting, and canopy cover per PRI 3.3 and 3.5. **The entry glass must be highly transparent per PRI 3.4.** PRI 3.7 recommends that entrances should be located at a corner to anchor the intersection at corner lots. The entry placement conforms with this guideline.

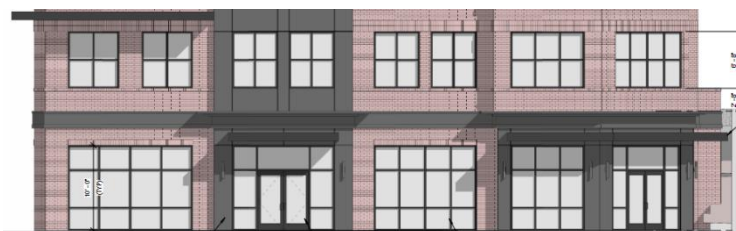
*Mordecai Street Elevation*

**Per PRI 4.1 and 4.2, transparency should be maximized along the ground floor to allow views of the use and activity within buildings and the use of darkly tinted or reflective glass is prohibited.** PRI 4.8 states that corner buildings should be designed to respond to their most prominent locations. Staff finds that the East McBee and Mordecai ground floors have been well activated, overall. However, **the applicants must meet with staff to address the blank wall along Mordecai through perforations in the brick or other methods of activation.**

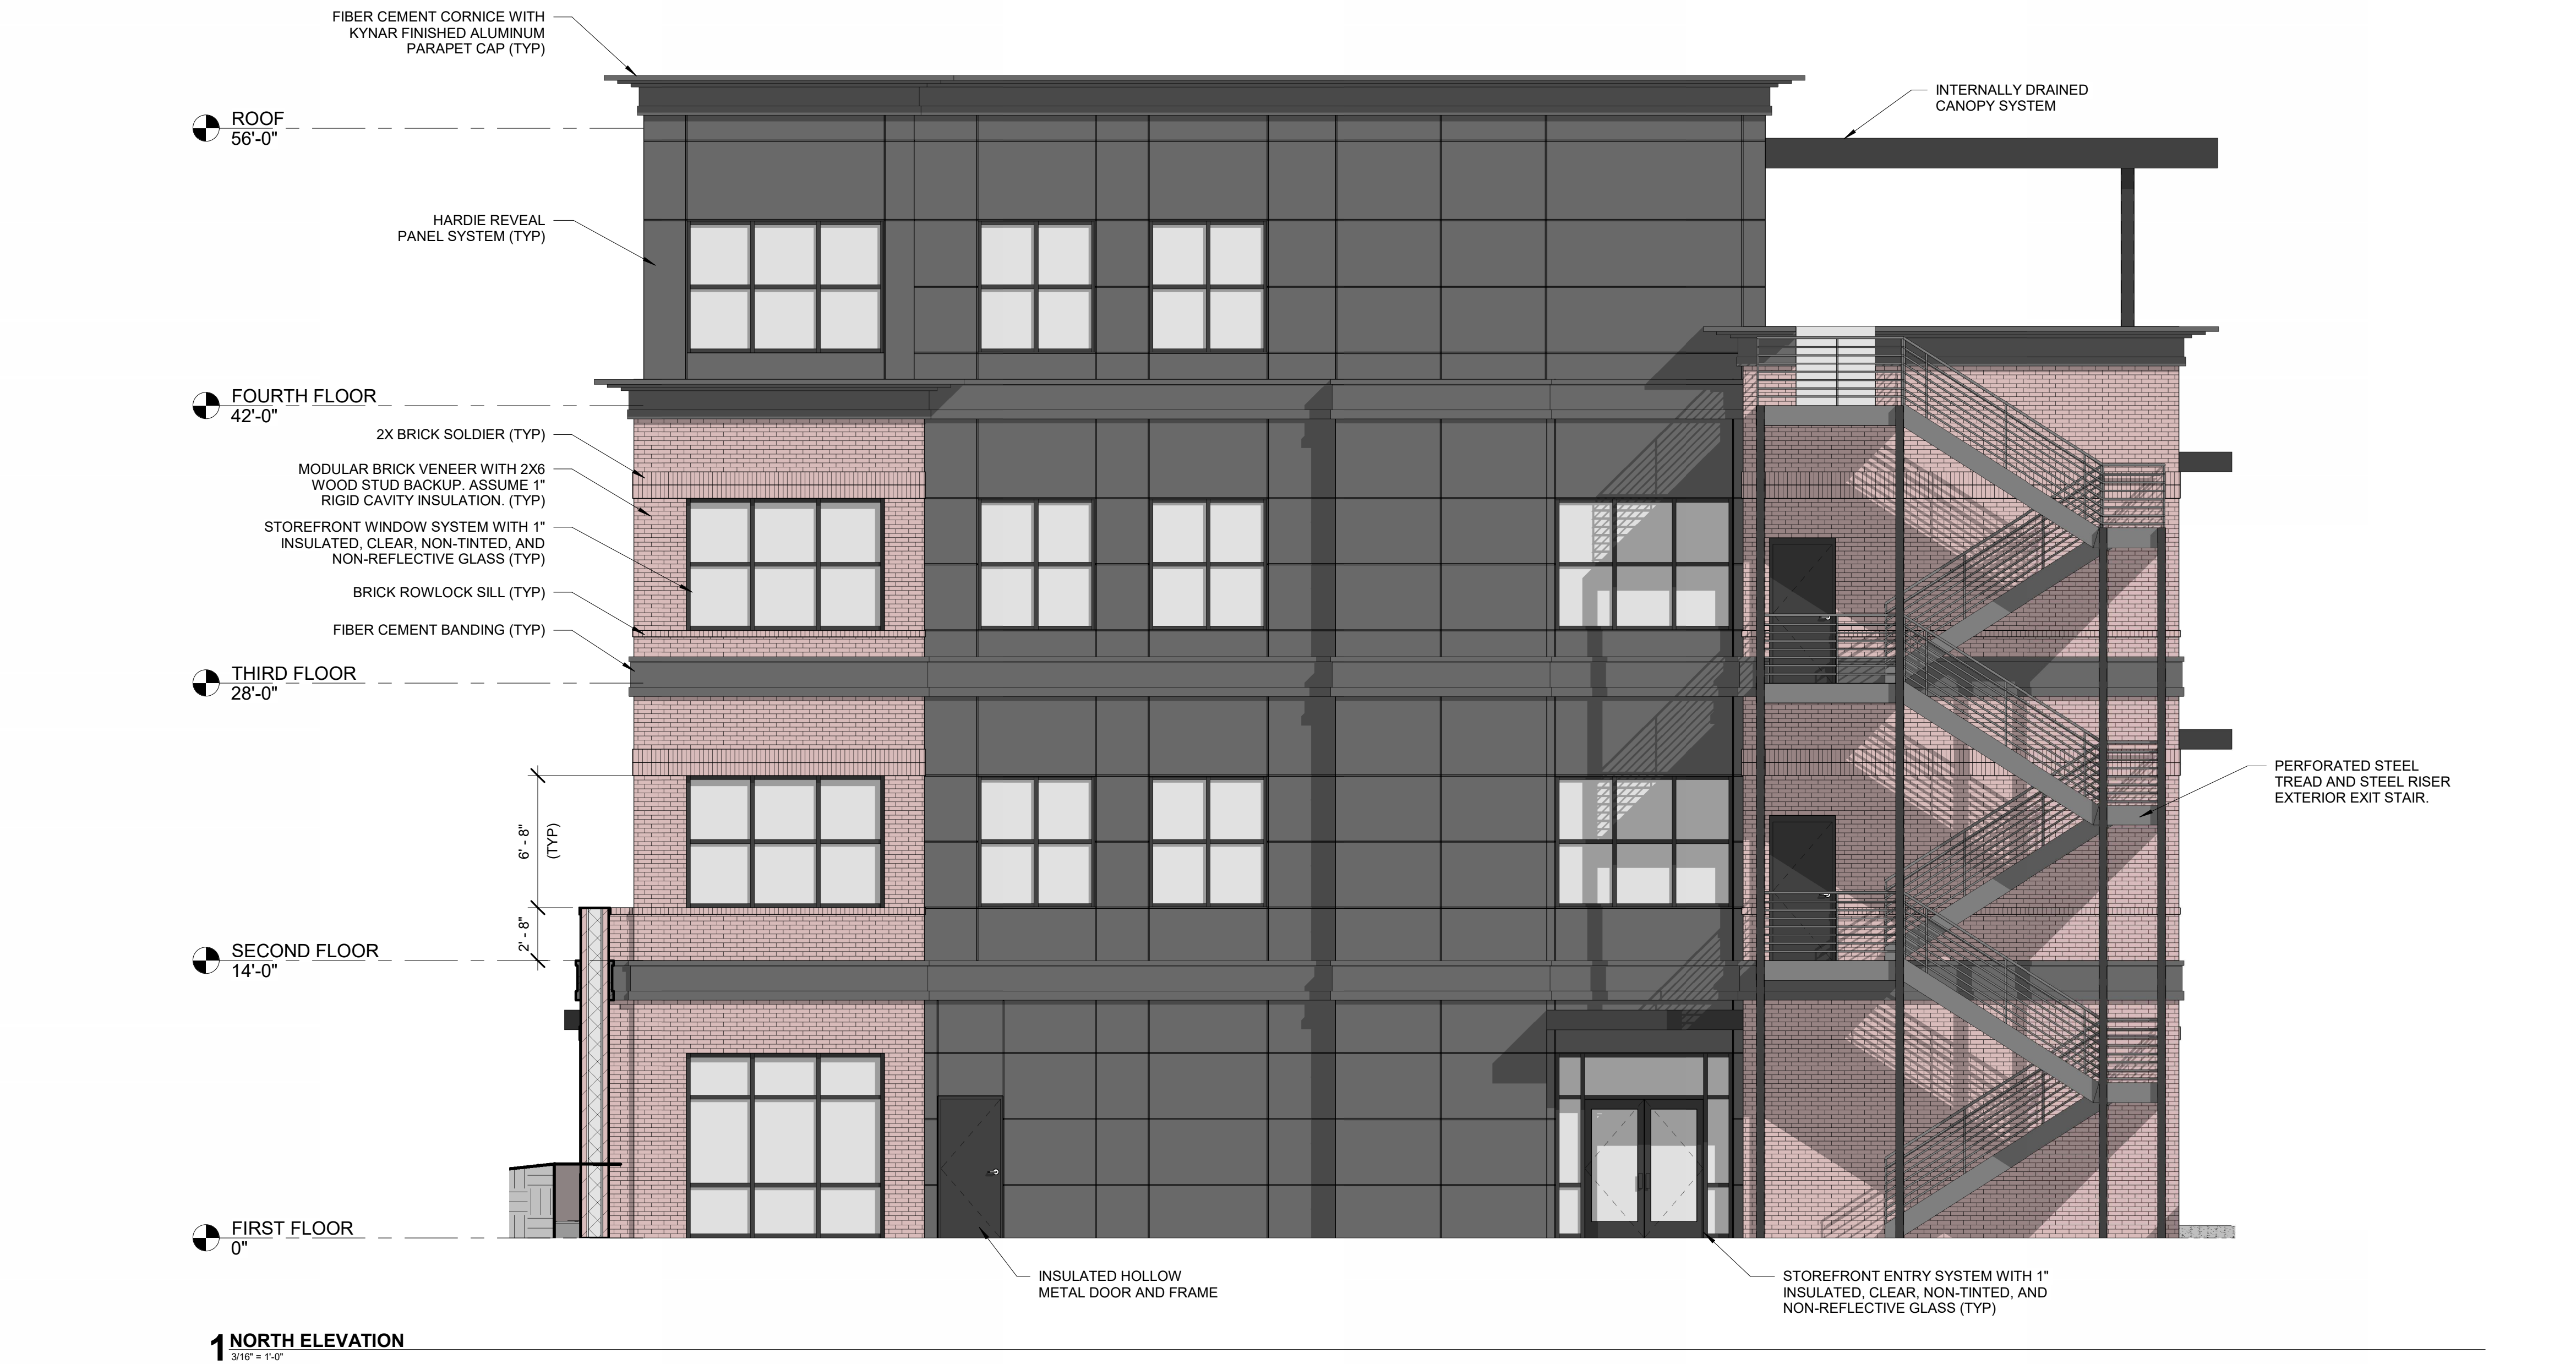
A2.00

MASONRY COLORS:  
BRK-1: MODULAR BRICK  
MANUFACTURER: CHEROKEE BRICK  
COLOR: VELOUR BURGUNDY  
BOND PATTERN: STRETCHER BOND

Per PRI 5.1, the building is articulated with dimensions to promote a sense of human scale. The mass is broken down by changes in brick tone, fenestration, and canopies, and other architectural details.

unified whole, per PRI 5.4. PRI 5.7 recommends that buildings on corner lots actively engage the public realm through architectural features such as chamfered corners, projected or recessed entries, and embellished doorways. Staff finds that the proposed design conforms with this guideline.
