**Planning Staff Report to  
Design Review Board  
January 6, 2026**  
*for the January 15, 2026 Public Hearing*

**Docket Number:** UH 25-1020  
**Applicant:** Dedrick Williams  
**Property Owner:** Allen Temple AME Church  
**Property Location:** 109 Green Avenue  
**Tax Map Number:** 0073000500100  
**Zoning:** MX-D, Mixed Use Downtown  
**Proposal:** Unreasonable Hardship Request to Demo Existing Structure  
**Staff Recommendation:** Denial

# Structural Evaluation and Demolition Justification Report

109 Green Ave, Greenville, SC 29601

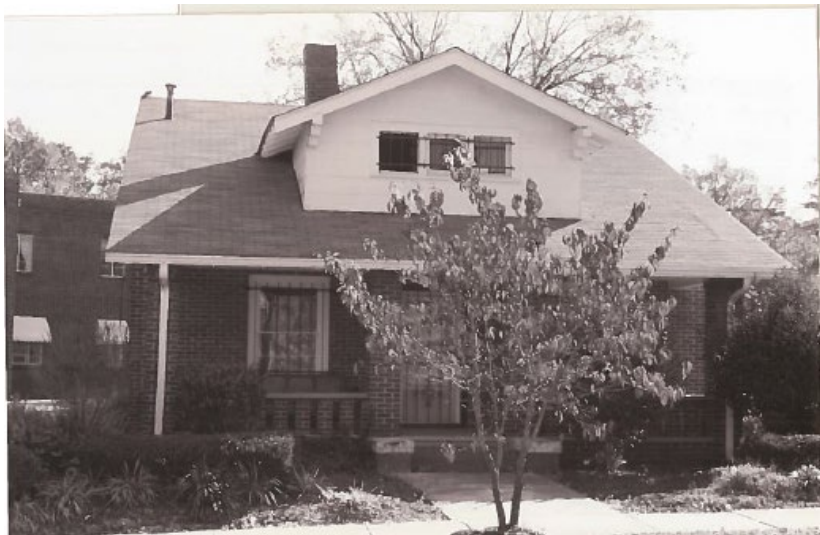
The parsonage structure is a 1-story brick side-gable bungalow with an engaged front porch, supported by brick posts and spanned by brick railing. The structure features a large front-gable, side dormer, an interior chimney, a single-leaf entry, and one over one windows.

The building is listed on the city's Historic Architectural Inventory and located within both the West End Preservation Overlay District and the Downtown Design Review Boundary.

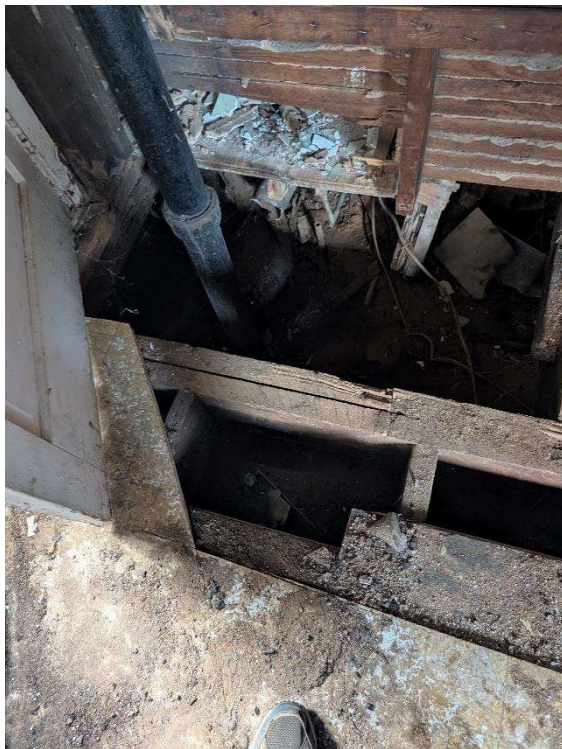
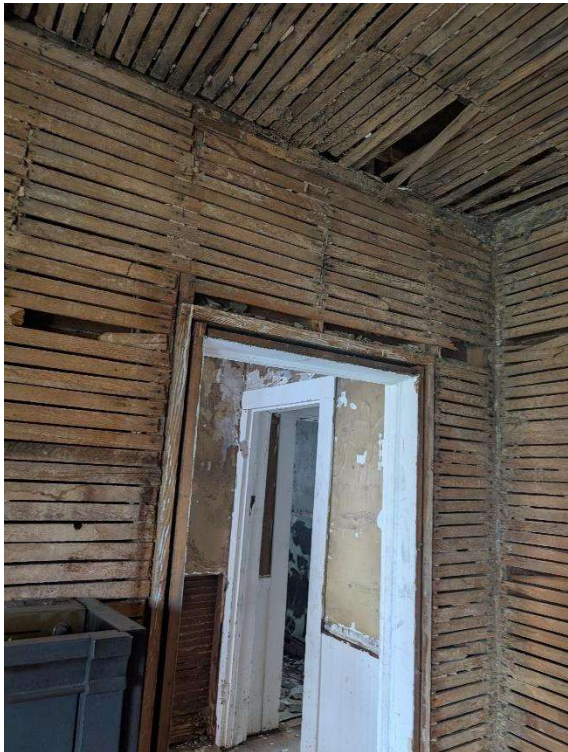
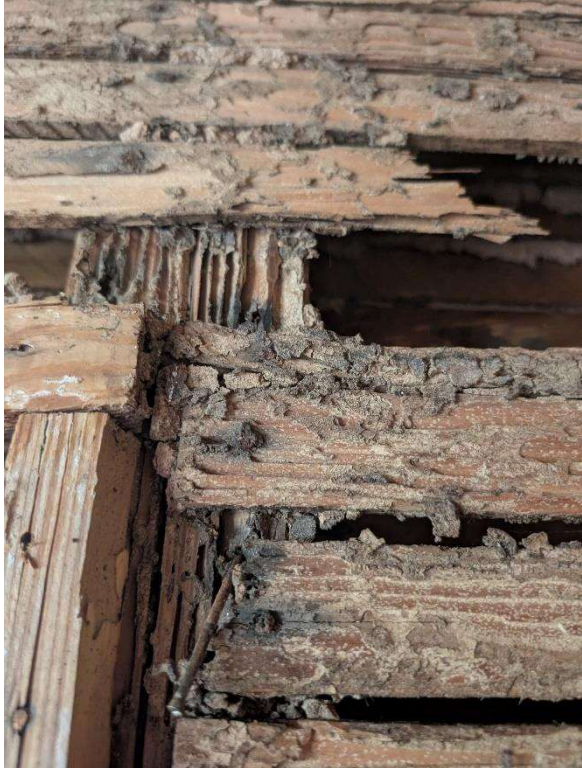
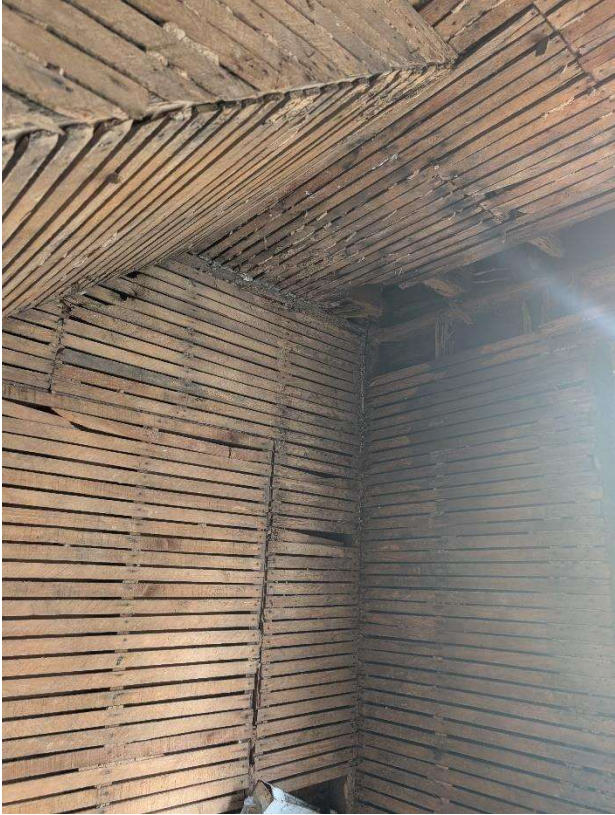
Representative photos of the house:

- The foundation consists of brick masonry that has mortar deterioration, leading to significant structural instability. The mortar has degraded in several piers and the soil under the piers would need to be evaluated for bearing capacity.

- The floor joists are undersized and span beyond their intended limits, failing to support the required live and dead loads. The floor joists at the rear of the structure are damaged due to their location relative to the soil in this area.
- The 2x10 joists used in the floor framing and supporting girders exceed safe span requirements, causing excessive deflection and vibration. The live and dead load requirements of the 2021 IBC would require reinforcement of the joists.
- Proper reinforcement would necessitate complete reconstruction of the lower-level supports, increasing renovation costs significantly.

- There is visible damage to the walls. The damage has been caused by termites.
- The existing framing does not provide adequate resistance to wind and environmental forces, compromising occupant safety.

- The roof rafters require furring to contain insulation that meets the 2021 IBC.
- Multiple rafters show evidence of rot, weakening the structural integrity of the roof.
-

Upon evaluating the existing structure at 109 Green Ave, I strongly and unequivocally recommend demolition as the most appropriate course of action. The building poses serious
